**MV “FREMANTLE HIGHWAY”**  
**IMO 9667344**  
**FIRE ON BOARD**  
**Casualty Date: July 25<sup>th</sup> 2023**  
**Casualty Place: Northsea – The Netherlands EEZ**  
**VERY SERIOUS MARINE CASUALTY**  
**REPORT NUMBER: R-016-2024-DIAM**

**SAFETY INVESTIGATION REPORT**

**FIRE ON BOARD M/V FREMANTLE HIGHWAY**

**At Northsea – The Netherlands EEZ**

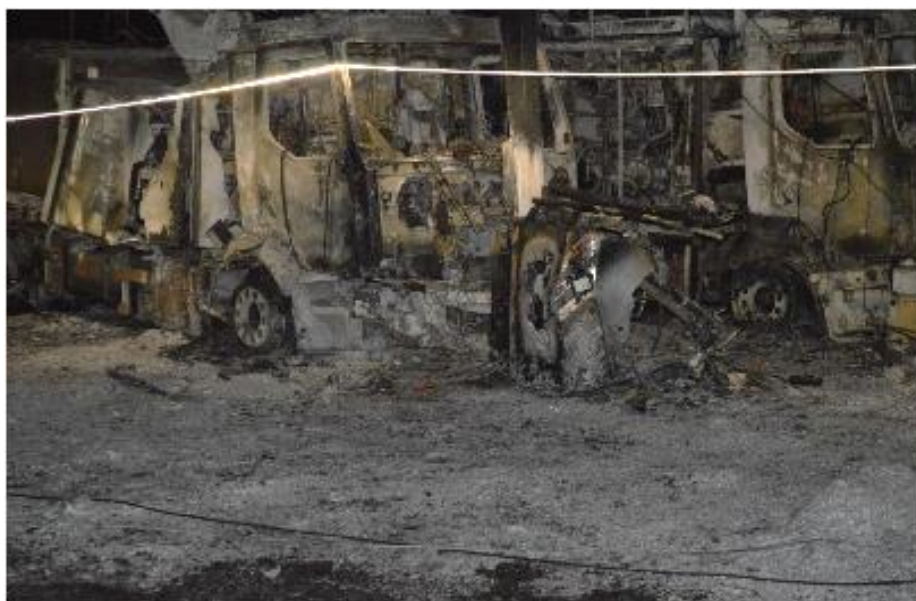
**FIGURE 6: TRUCKS EQUIPPED WITH AN AERIAL PLATFORM ON THE  
5<sup>TH</sup> DECK**

Due to the harmful substances on board, the investigation on board was conducted on a limited basis, under supervision and with the proper personal protective equipment. On the starboard side, the “fire experts’ team” entered the vessel at the pilot entrance on the **5DK**. At the level of the bow, the flexible **6DK** was placed in the highest position. On **5DK** were mobile cranes, transfer cranes and trucks, equipped with an aerial platform stored. Parts of the floor of the **5DK** were covered with solidified aluminum, which had flowed through holes in the decks above.

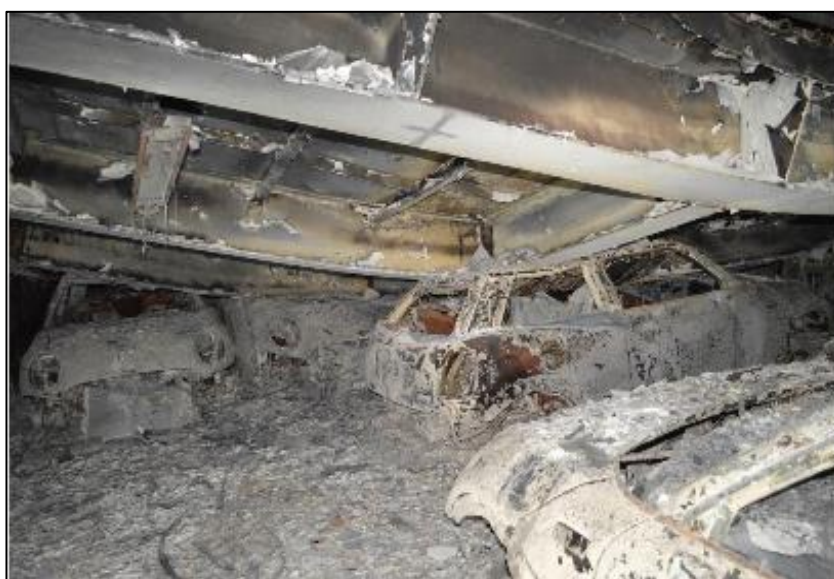
**FIGURE 7: CRUSHED VEHICLES AT 7<sup>TH</sup> DECK**  
(Source: Physical inspection O/B - Fire Expert Report)

Through the stairwell in the bow of the vessel, the “fire experts’ team” went to the mooring deck on the **7DK**. On the mooring deck lays an EEBD (Emergency Escape Breathing Device). From the previously received statements and interviews with the crew members, the “fire experts’ team” concluded that the EEBD was left by the third officer before he jumped in the sea/water. The life rafts on the mooring deck were still in place at the embarkation stations. Inside at the **7DK**, seen from the bow, the total destruction of the stowed cars was visible, **8DK deck** came down partially and crushed several vehicles underneath.

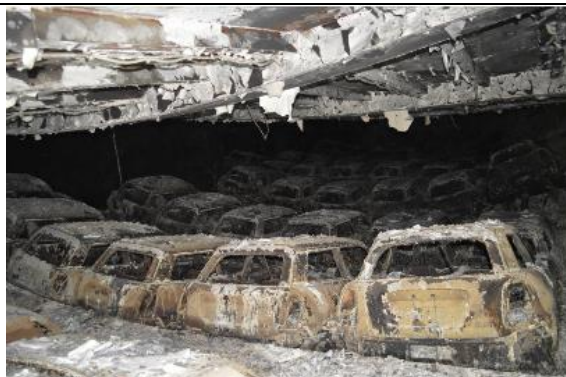
**FIGURE 8: 8<sup>TH</sup> DECK PORT SIDE**  
(Source: Physical inspection O/B - Fire Expert Report)

The vehicles on the port side of **8DK** were still identifiable as vehicles. The vehicles on the starboard side are barely recognizable as vehicles; the destruction was enormous, and therefore, it can be considered as the area where the fire started. It was not possible for the “fire experts’ team” to go between the remains of the vehicles. Sections of **8DK** were deformed and other sections had fallen down in their entirety. Traces found on sections of **8DK** such as parts that had fallen from cars, show that the collapse of certain sections of this deck was a result of the fire which developed at a later stage on **7DK**.

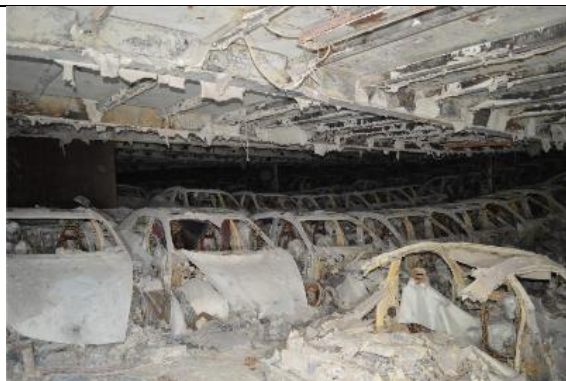
**FIGURE 10A: 9<sup>TH</sup> DECK BURNED CARS**  
(Source: Physical inspection O/B - Fire Expert Report)

The vehicles on **9, 10, 11, 12DK** were also burned. Although the visible damage to the vehicles on the **12DK** differs from what is visible on the decks below. Probably a lack of oxygen, due to the huge smoke development, affected the burning process on **12DK**

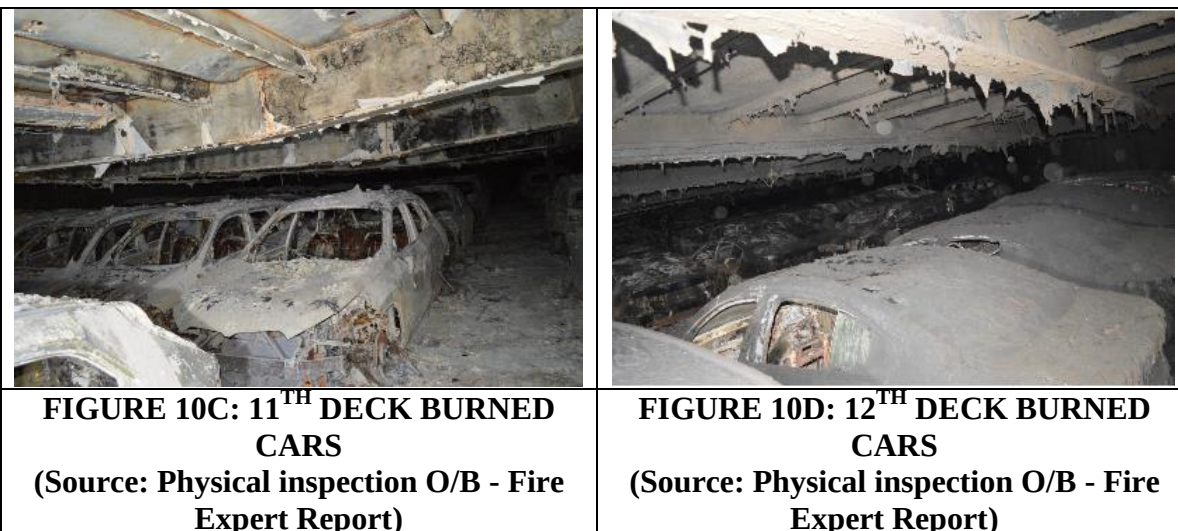
The upper deck was heavily deformed by heat. After initially being convex, the upper deck collapsed. The accommodation and bridge were also completely destroyed by the fire. All possible data carriers, as well as hard copies of records and reports on the bridge, were destroyed.
