**MV “FREMANTLE HIGHWAY”**  
**IMO 9667344**  
**FIRE ON BOARD**  
**Casualty Date: July 25<sup>th</sup> 2023**  
**Casualty Place: Northsea – The Netherlands EEZ**  
**VERY SERIOUS MARINE CASUALTY**  
**REPORT NUMBER: R-016-2024-DIAM**

**SAFETY INVESTIGATION REPORT**

**FIRE ON BOARD M/V FREMANTLE HIGHWAY**

**At Northsea – The Netherlands EEZ**

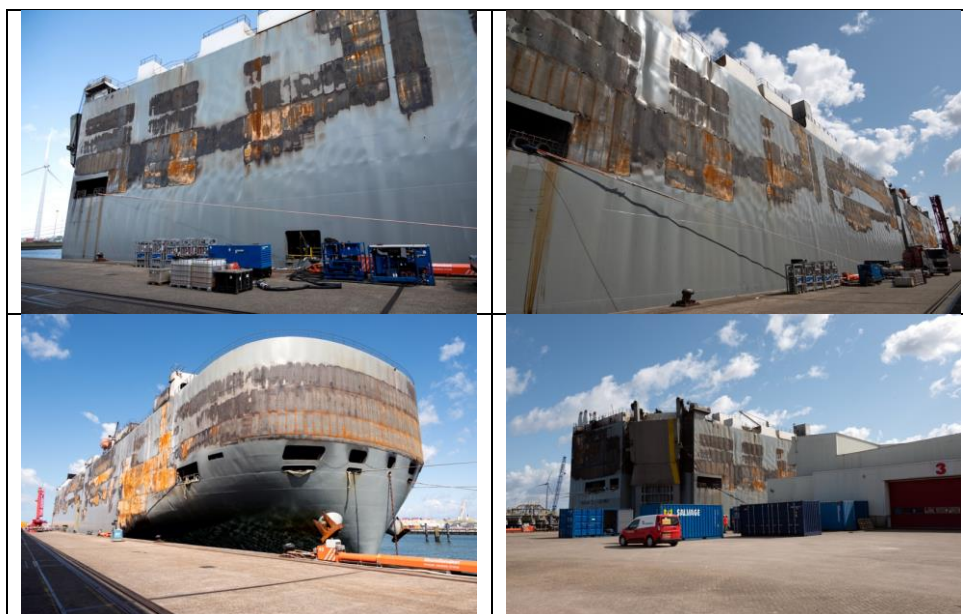
**FIGURE 1: FREMANTLE HIGHWAY VIEW HULL**  
(Source: Photos taken during physical attendance o/b)

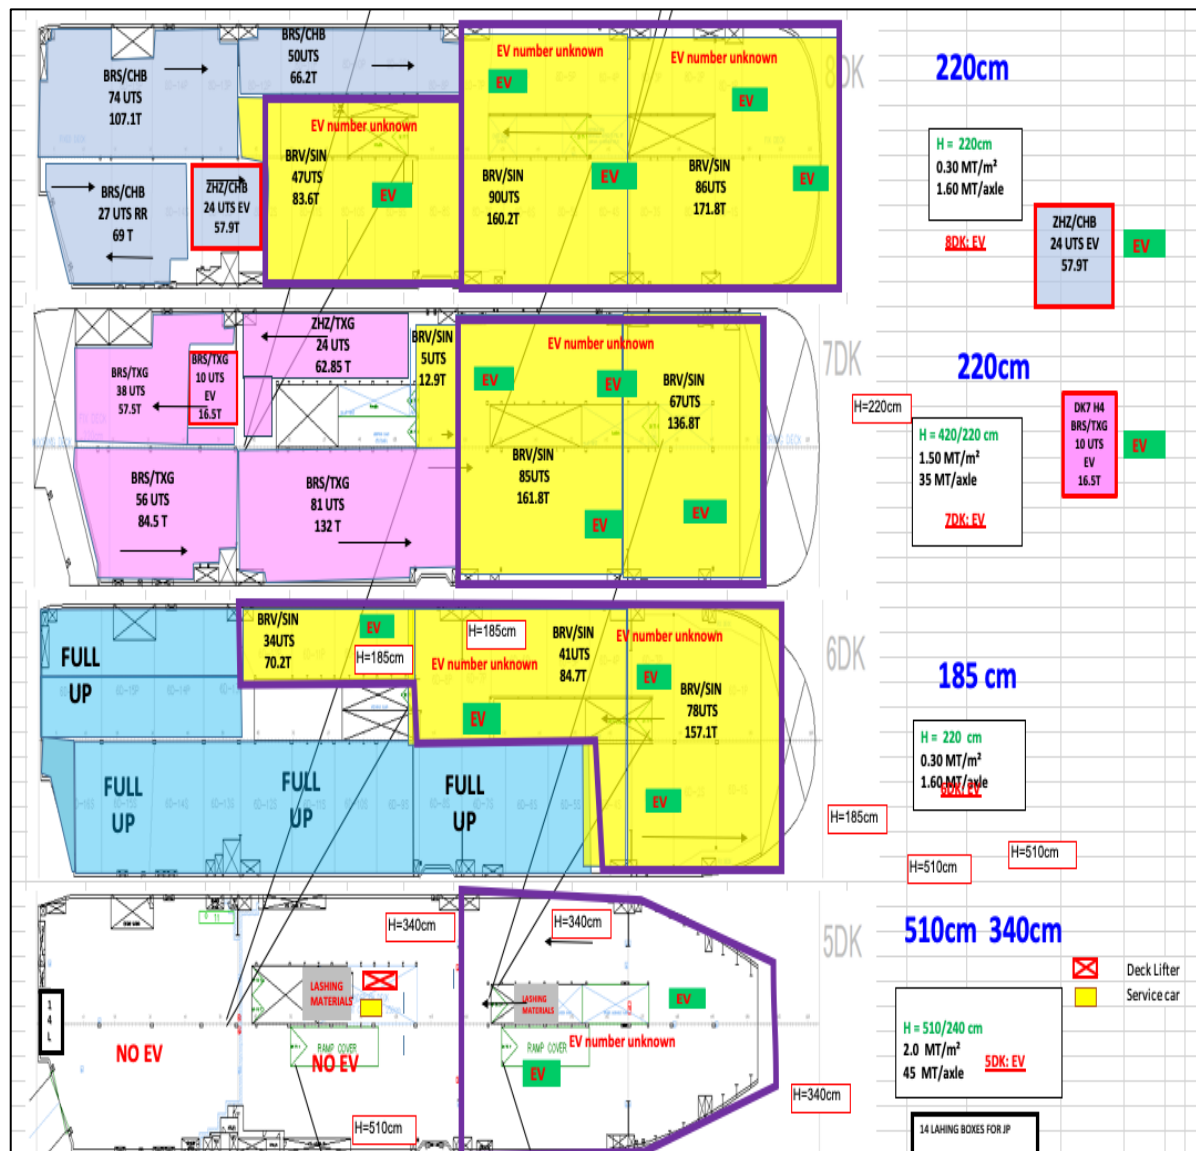
**FIGURE 20B: STOWAGE PLAN PART B**  
 (Source: Submitted by Operators)

1. The Stowage plan for Deck 8, after loading at Bremerhaven is shown in **Figure 20B**. BMW Group cargo is indicated to fill all four holds of Deck 8 with the exception of some Audis and VWs forward in Hold 1.
2. According to this document 27 RR units (we understand RR to denote Rolls Royce) were loaded in Bristol for discharge in Chiba. These were stowed aft on Deck 8 (starboard side).
3. A group of Electric Vehicles (EVs), (Figure 3, red box) were stowed on Deck 8 to starboard of the centreline at the Hold 3/4 boundary. These EVs were loaded in Zeebrugge for discharge in Chiba.
4. We consider that the 74 Unit and 50 Unit blocks on the port side relate to Minis, based on the number and weights of the units and the fact they were loaded in Bristol, again for discharge in Chiba.
5. The BMWs loaded in Bremerhaven completed the loading of Holds 2 and 3 on Deck 8, and some of Hold 1.

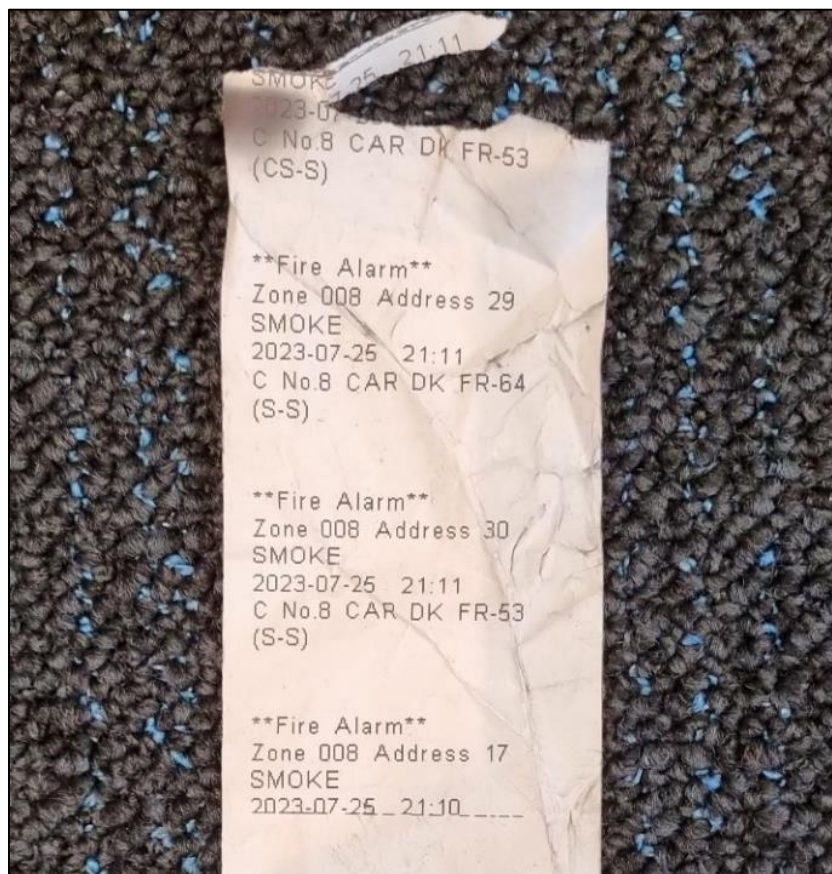
**FIGURE 28: PRINT OUT OF FIRE ALARM**  
(Source: Obtained from a crewmember overall/immersion suit by the Dutch police on July 26<sup>th</sup>, 2023 and shared with the DSB/PMA)
